*Passage Success of Warner Suckers at the MC Diversion on Twentymile
Creek*

ANNUAL PROGRESS REPORT
FISH RESEARCH PROJECT
OREGON

PROJECT TITLE: Passage Success of Warner Suckers at the MC Diversion on
Twentymile Creek

PROJECT PERIOD: April 2018–November 2018

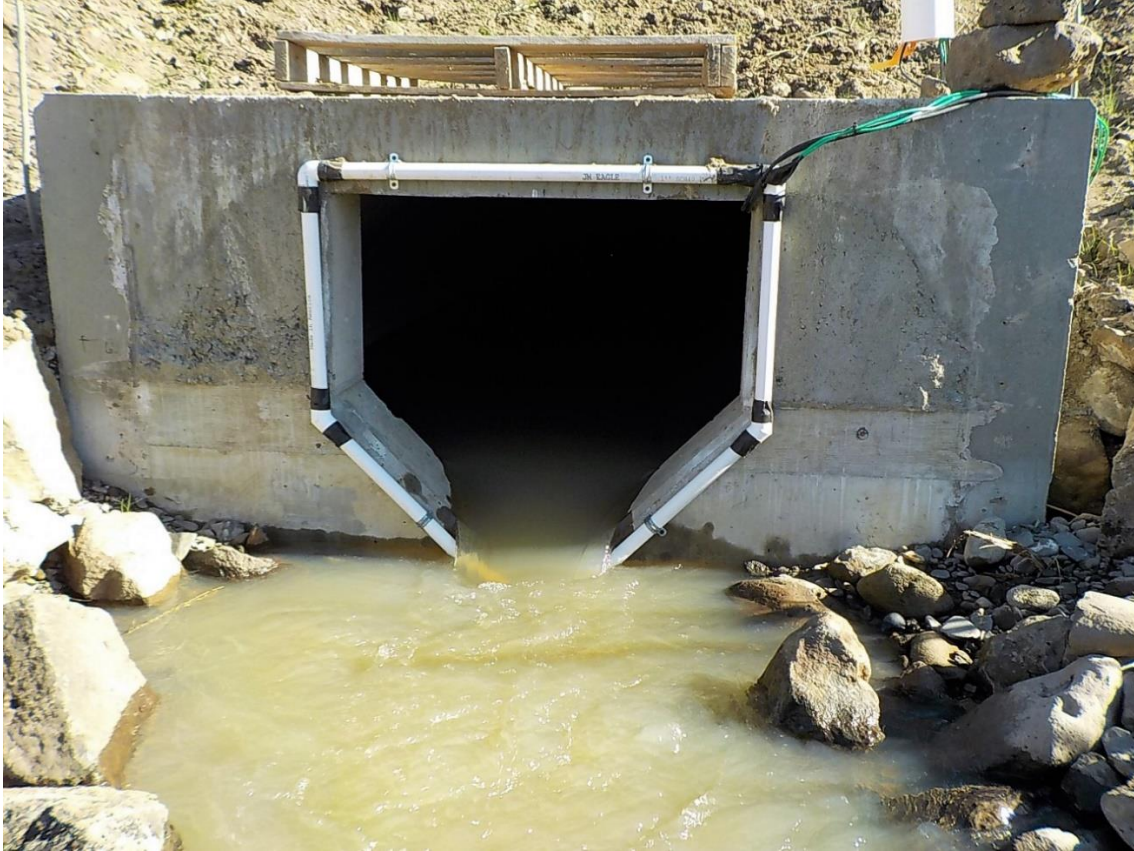
Figure 2. The V-notch weir and loop PIT antenna on the downstream end of box culvert at the MC Diversion fish passage project. Photo taken on 03 May 2018.

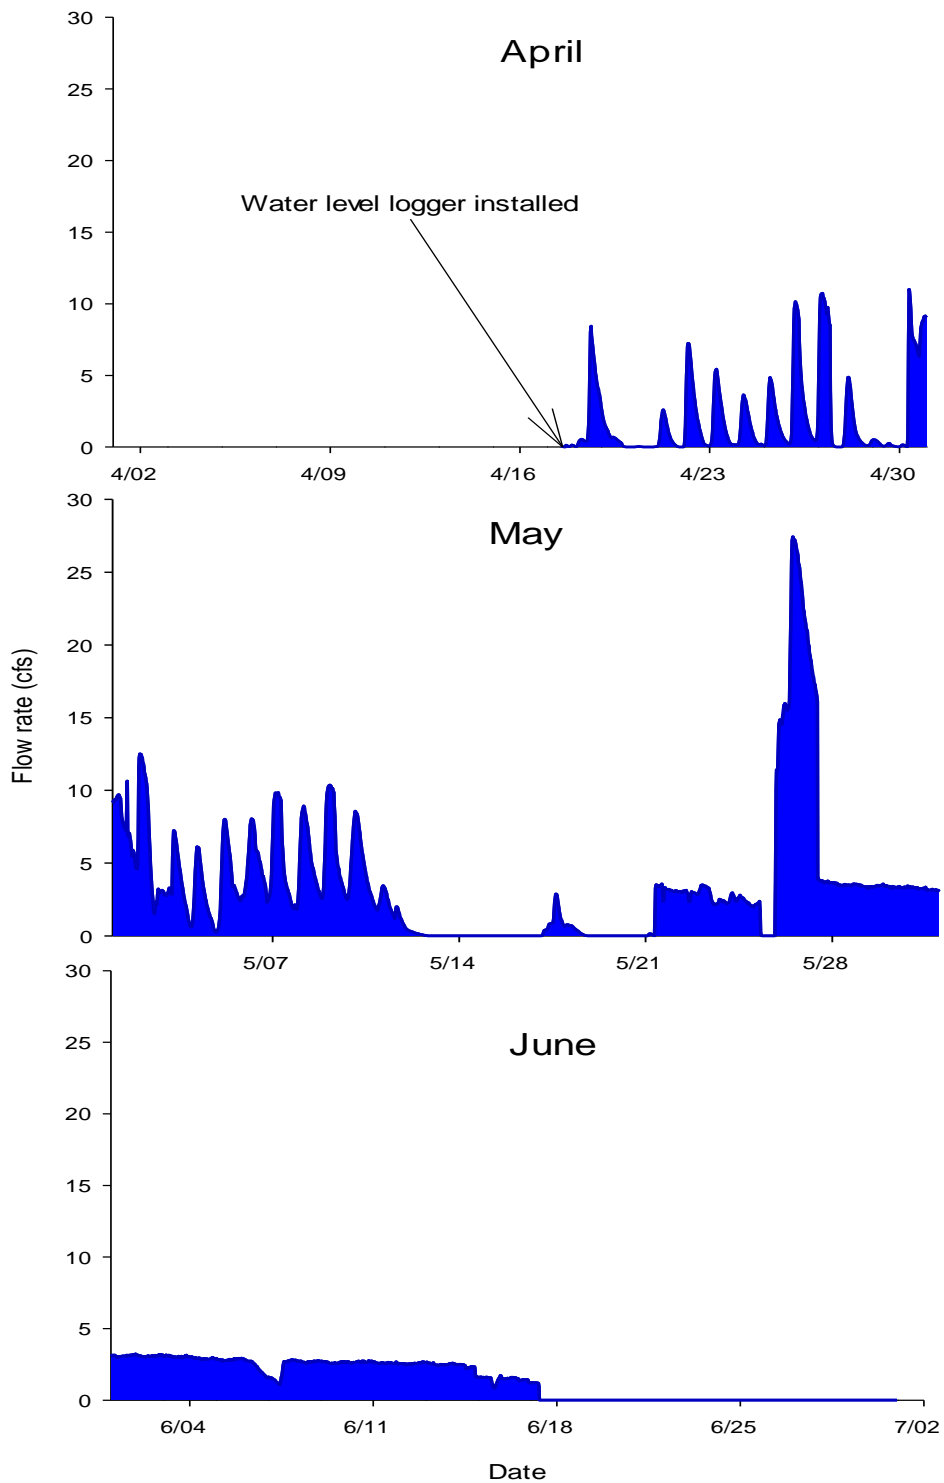
Flow through the fish bypass was inconsistent during the study period. From April to early May, flows oscillated daily due to the water freeze/thaw cycle occurring in the Twentymile Creek basin (Figure 3). This usually resulted in brief periods of no flow in the bypass in April. The bypass rarely operated in mid-May. After a large flow pulse through the bypass on 26 May, associated with a flood event on Twentymile Creek (Appendix Figure 1), flows through the bypass remained relatively stable at approximately 3 cfs ($0.085 \text{ m}^3\text{s}^{-1}$) until the bypass was shut down on 17 June (Figure 3). Throughout the study period, attempts to increase flow through the bypass by manipulating the slide gates resulted in water overtopping the MC dam and draining to Greaser Reservoir. Therefore, irrigators operated the bypass below its designed target flows of 5.8–14.7 cfs ($0.164\text{--}0.416 \text{ m}^3\text{s}^{-1}$) with most flow entering the MC Canal via the old culverts.

Figure 3. Flow rates through the bypass weir during the study period, 2018. Peak flow on 26 May was likely overestimated since water level was up the vertical walls of the weir, thereby biasing Kindsvater-Shen calculation for V-notch weir.

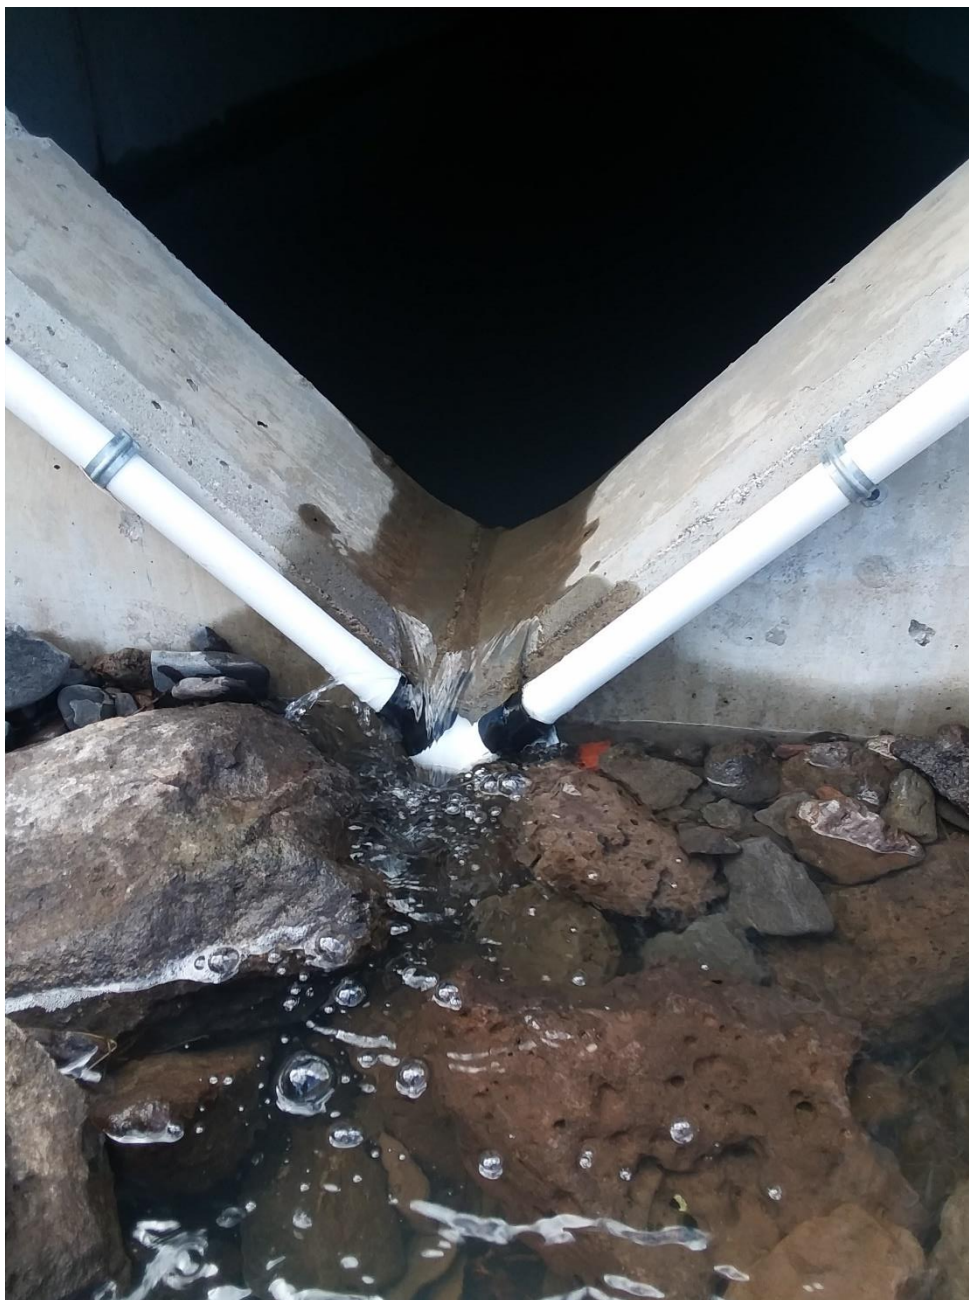
The inability to increase flows through the bypass without causing water to overtop the MC Dam resulted in inconsistent and generally low flows through the bypass during the study period. This problem was recognized by managers soon after bypass operations began and structural modifications to improve flow have been initiated. Despite the operational limitations during the study period, some useful information was gained on flow requirements needed for successful fish passage. The successful passage of one fish through the bypass indicated that fish can pass the weir when flows are approximately 8 cfs ($0.23 \text{ m}^3\text{s}^{-1}$). Fish were unsuccessful at passing over the weir when flows were <3.6 cfs ($0.10 \text{ m}^3\text{s}^{-1}$), including one Redband Trout. One possible reason for unsuccessful upstream passage at these low flows may be the large rocks located directly downstream of the weir (Appendix Figure 2). Passage during low flow conditions could possibly be improved if the rocks were removed to allow better access to the weir notch.

Appendix Figure 2. Photo of large rocks below the bypass weir entrance, 2018.
